SUBJECT: MLK Motor End Plates Improvement

Affected Products: All MLK & HLK Hoist Models and Motor Assemblies

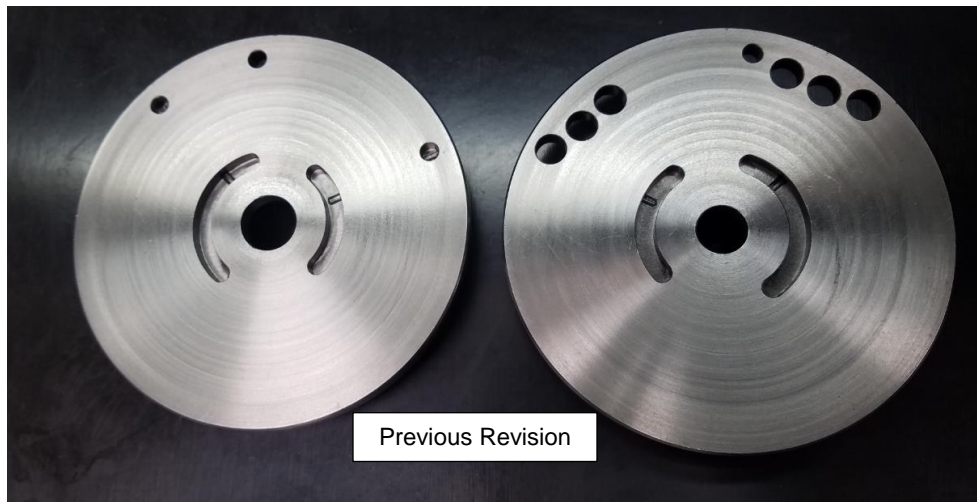
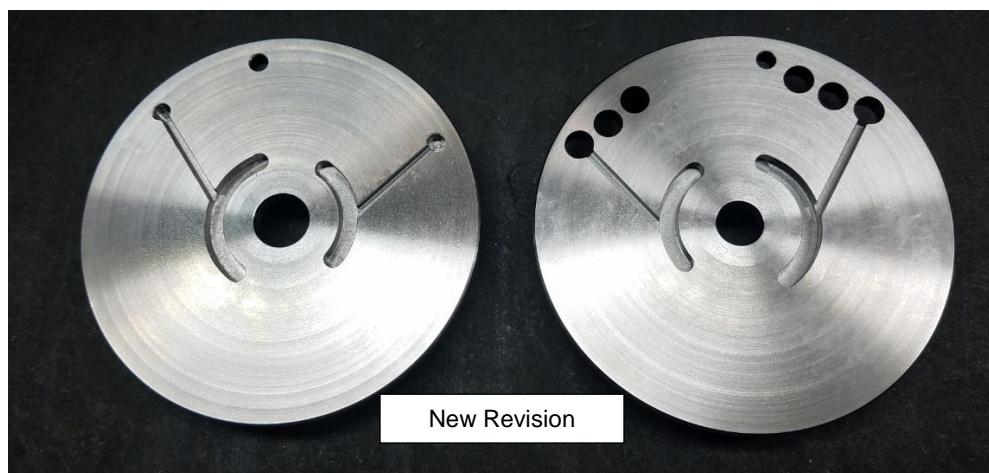
As a running change, Ingersoll Rand is updating the Motor End Plates on all MLK and HLK hoists. Part numbers 03193091 (MR-12) and 03193075 (MR-11) will not change. **Old and new end plates can be used interchangeably.**

There is/was no functional or quality issue that required the update of the motor end plates. It is solely a manufacturability update only. The concept is the same as is used on the CLK-Series hoist motor end plates and was proven to produce equivalent performance with the prior design before being implemented. The two existing air channels have been exposed on the surface of the end plates as shown in the "New Revision" photo below.

No action is required. The bulletin is for informational purposes only.
