SUBJECT: MLK Motor End Plates Improvement

Affected Products: All MLK & HLK Hoist Models and Motor Assemblies

Affected Date Range: All units built after July 2019

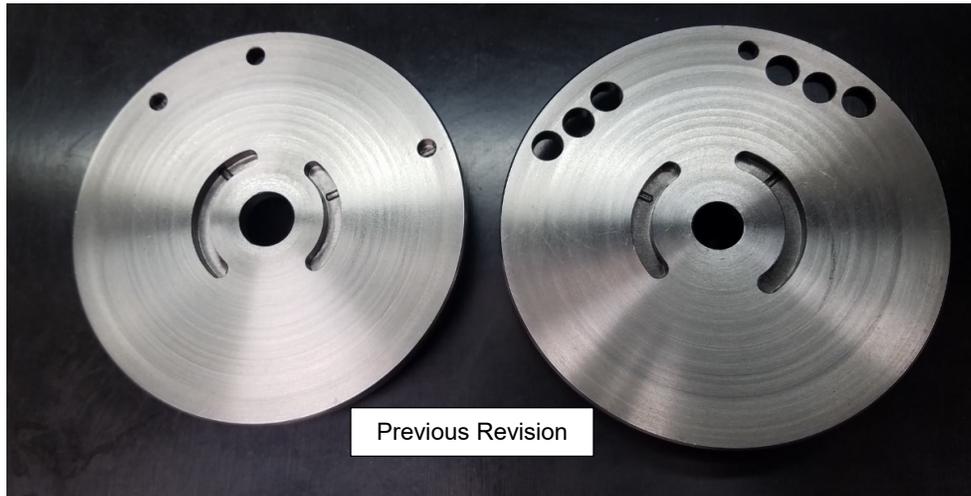
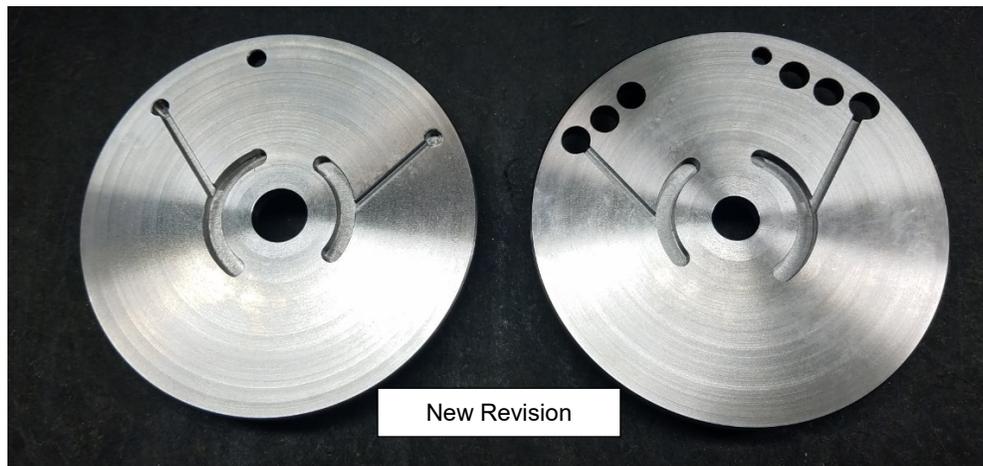
There is/was no functional or quality issue that required the update of the motor end plates. It is solely a manufacturability update only. The concept is the same as is used on the CLK-Series hoist motor end plates and was proven to produce equivalent performance with the prior design before being implemented. The two existing air channels have been exposed on the surface of the end plates as shown in the "New Revision" photo below.

No action is required. The bulletin is for informational purposes only.
